UNITED STATES ENVIRONMENTAL PROTECTION AGENCY **REGION 10**

MEMORANDUM

SUBJECT: Potlatch Free Product Recovery System

Avery Landing Site, Avery, Idaho

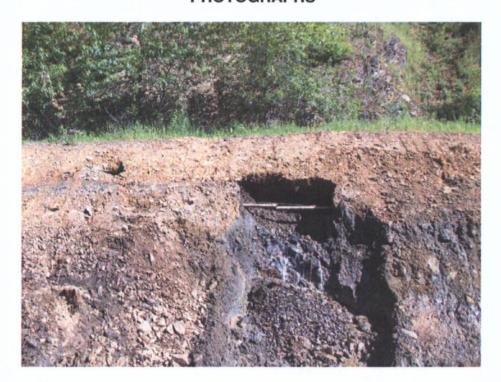
1. Excavation of the FPRS infiltration trench (note the presence of the two PVC pipes – one solid [carrier] pipe and one perforated pipe – in the infiltration trench)

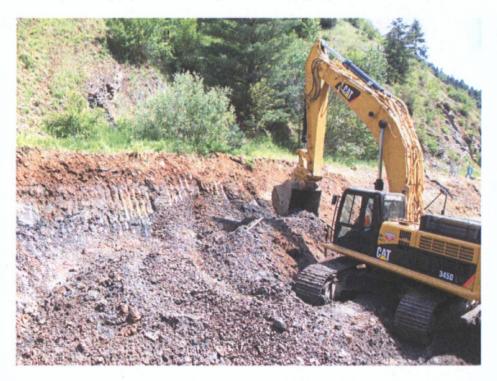
2. Excavation of the FPRS infiltration trench (note the outline of the infiltration trench and the presence of the PVC pipe, crushed rock, and petroleum-stained soil)

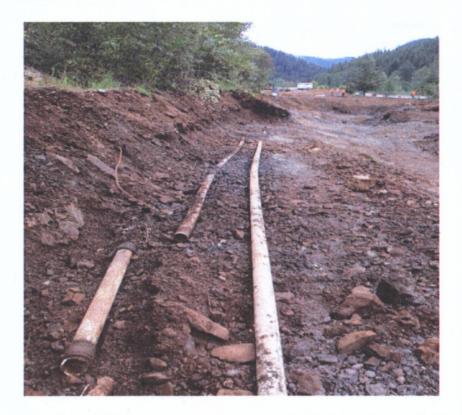
3. Excavation of the FPRS infiltration trench; 3-inch PVC carrier and infiltration pipes (facing east)

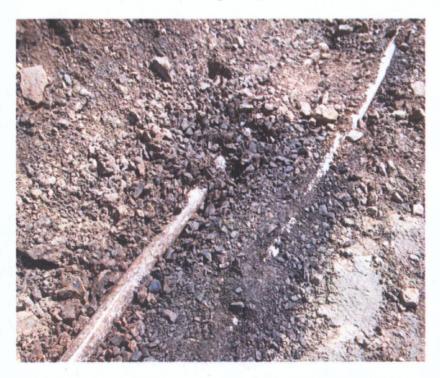
4. 3-inch PVC carrier and infiltration pipes surrounded by crushed rock and embedded in infiltration trench

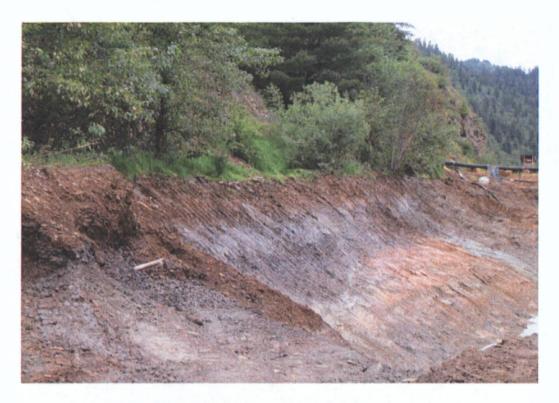
Petroleum was visibly observed in the subsurface soil throughout the entire length and width of the infiltration trench, and a strong petroleum odor was also noted along the full length of the trench. Petroleum was also observed in soil north and south of the constructed dimensions of the infiltration trench, and petroleum-stained soil was visible 6 to 8 feet below the bottom of the crushed rock-filled infiltration trench (see Photographs 5, 6, and 7).

5. Excavation of the FPRS infiltration trench (facing east) (note the outline of the infiltration trench and the presence of petroleum-stained soil)

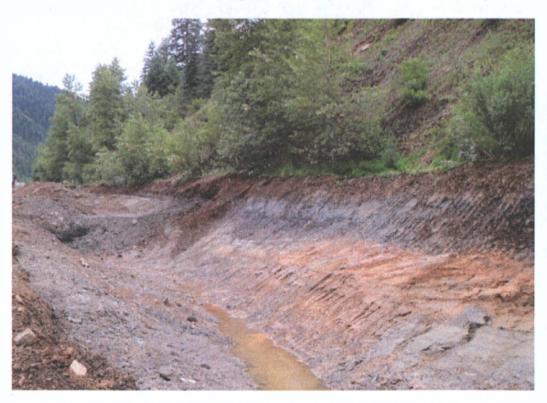
6. Excavation of the FPRS infiltration trench (facing west) (note the outline of the infiltration trench and the presence of petroleum stained soil)

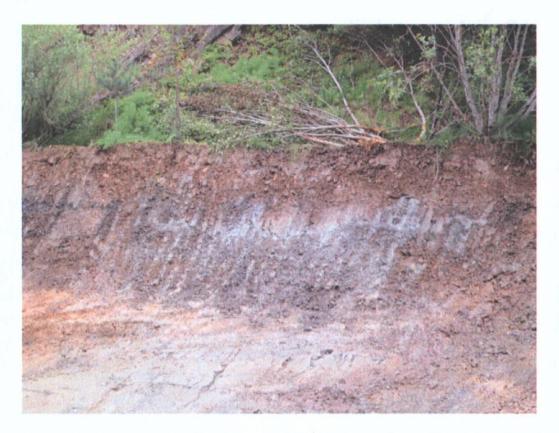
7. Excavation of the FPRS infiltration trench (note the outline of the infiltration trench and the presence of petroleum-stained soil)
